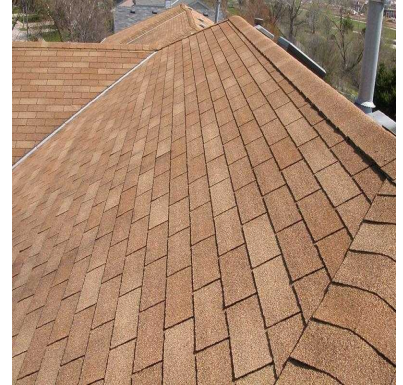
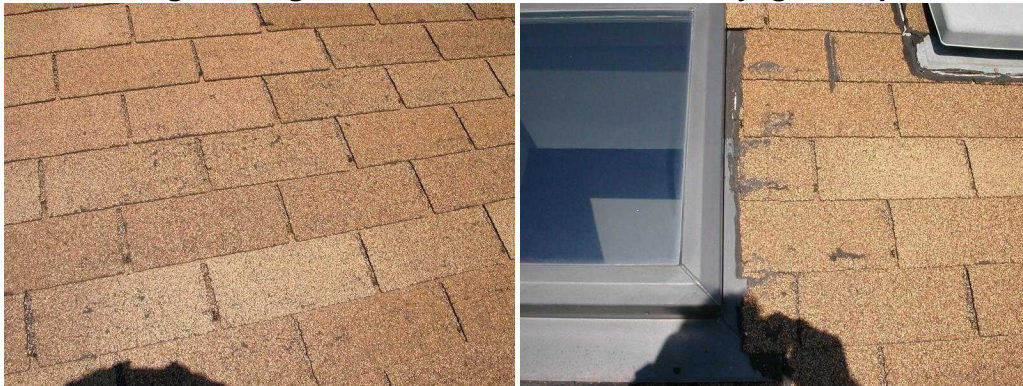
Material: **Composition shingle.** Roofing shows signs of aging. The estimated expected life of the shingles is 3-5 more years. Periodic repairs may be needed during that time. There are some damaged shingles on the rear side near the skylight. Repairs are recommended.

1. Entire roof Roof Surface Material: **Composition shingle. Roofing shows signs of aging. The estimated expected life of the shingles is 3-5 more years. Periodic repairs may be needed during that time. There are some damaged shingles on the rear side near the skylight. Repairs are recommended.**

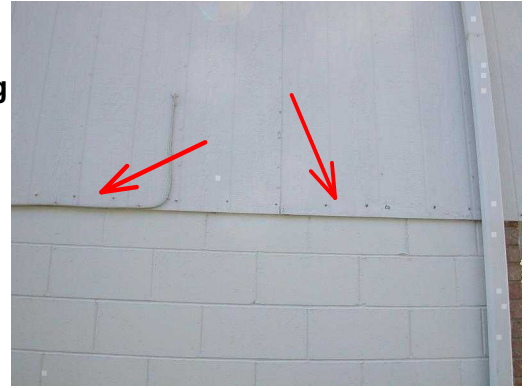
Siding Type **Composition Board. Siding swollen/deteriorated @ the bottom edges on the east, west and south sides. Repairs are recommended. Siding swollen in other locations - keep it painted and sealed.**

2. Siding Type **Composition Board. Siding swollen/deteriorated @ the bottom edges on the east, west and south sides. Repairs are recommended. Siding swollen in other locations - keep it painted and sealed.**
3. Window Frames/Sills **Wood rot present @ the front basement window. Repairs are recommended.**

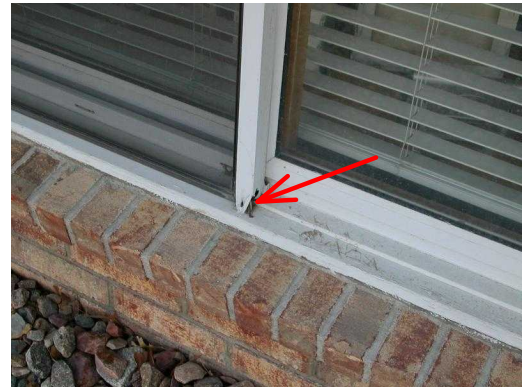
Veneer **Brick**
 Soffit/Fascia/Trim **Composition board**
 Exterior Doors:
 Window Frames/Sills **Wood rot present @ the front basement window. Repairs are recommended.**

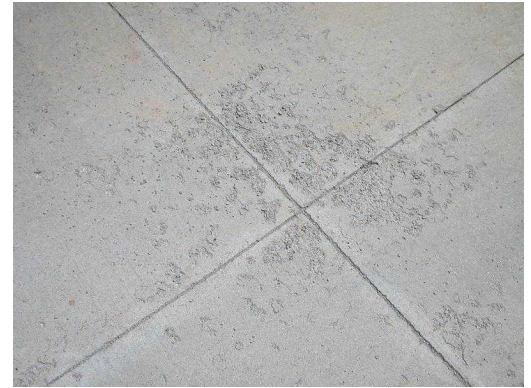
Driveway: **Concrete.** Portions of the concrete on the driveway are spalling (approx. 7 sections). This will shorten its life.

4. Driveway: **Concrete. Portions of the concrete on the driveway are spalling (approx. 7 sections). This will shorten its life.**

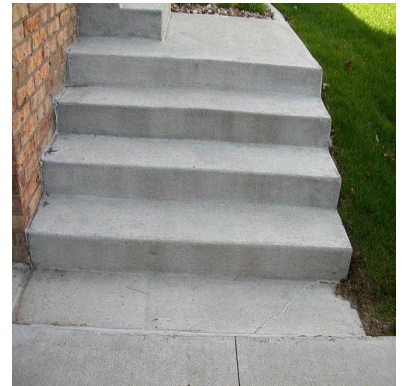
Walks/Steps: **Concrete.** Handrail missing @ the front steps. Recommend one be installed for safety.

1. Walks/Steps: **Concrete. Handrail missing @ the front steps. Recommend one be installed for safety.**

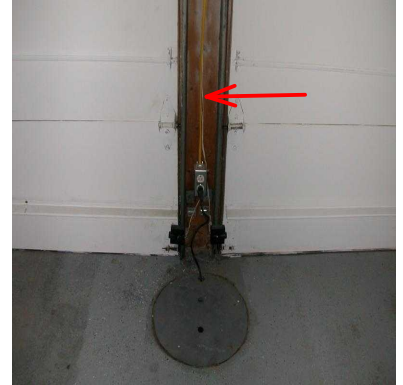
- Electrical: **110 VAC outlets and lighting circuits. Exposed electrical wiring @ garage - should be installed in a conduit pipe for safety.**

2. Tuck under Garage Electrical: **110 VAC outlets and lighting circuits. Exposed electrical wiring @ garage - should be installed in a conduit pipe for safety.**

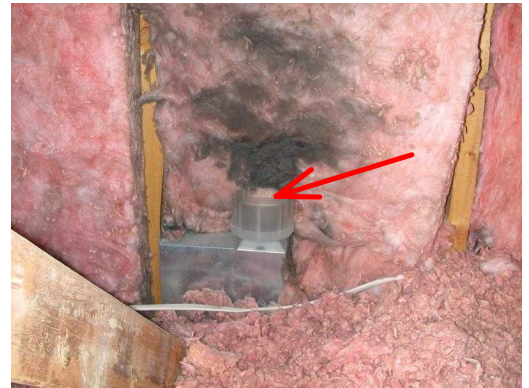
- Toilet:
- Shower/Surround:
- Tub/Surround:
- Ceiling/Walls/Floor:
- Sink/Basin/Vanity Top
- Electrical: **110 VAC outlets and lighting circuits, 110 VAC GFCI**
- HVAC Source: **Forced air - registers**
- Ventilation: **The bathroom exhaust fan vents into the attic insulation. Recommend it be ducted so it is near a roof vent for proper exhaust. Possible mold on the insulation here.**

5. 1st Floor Hall Bathroom Ventilation: **The bathroom exhaust fan vents into the attic insulation. Recommend it be ducted so it is near a roof vent for proper exhaust. Possible mold on the insulation here.**
6. Lower Level Bathroom HVAC Source: **Forced air - registers. No air registers present in this bathroom.**

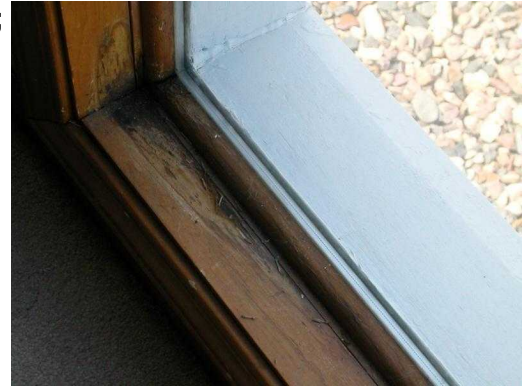
Windows: **Defective thermal seal(s) @ approx. 6 windows; one by kitchen sink, one at family room by fireplace, one at master bedroom, one at the dining room picture window, one at the lower level rear and one at the lower level front.**

The dining room picture window has some moisture damage along the interior sill.

2. All interior finished rooms Interior Rooms Windows: **Defective thermal seal(s) @ approx. 6 windows; one by kitchen sink, one at family room by fireplace, one at master bedroom, one at the dining room picture window, one at the lower level rear and one at the lower level front.**

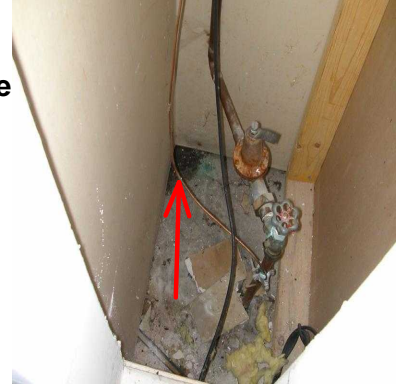
- Structure Type: **Masonry and wood frame**
- Foundation Walls: **Concrete Block. Moisture stains present @ the water meter closet at the NW corner of the basement, indicating prior dampness/seepage may have occurred. Recommend that the buyer request from the seller any information they have concerning any previous or ongoing water seepage that has occurred.**
- Basement/lower level is mostly finished. This limited the visual inspection of the structural components. Excess storage in the basement limited the inspection.**

8. Foundation Walls: **Concrete Block. Moisture stains present @ the water meter closet at the NW corner of the basement, indicating prior dampness/seepage may have occurred. Recommend that the buyer request from the seller any information they have concerning any previous or ongoing water seepage that has occurred. Basement/lower level is mostly finished. This limited the visual inspection of the structural components. Excess storage in the basement limited the inspection.**

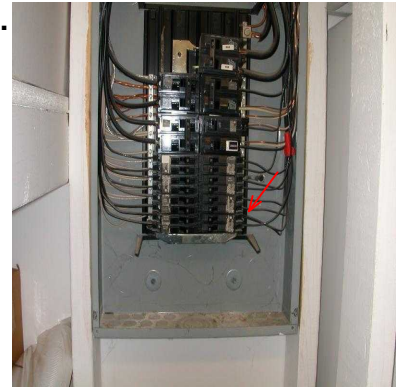
- Breakers/Fuses: **Multiple tapped circuit breaker - one at main panel.**
Repairs are recommended for safety.

3. Basement Electric Panel Breakers/Fuses: **Multiple tapped circuit breaker - one at main panel. Repairs are recommended for safety.**

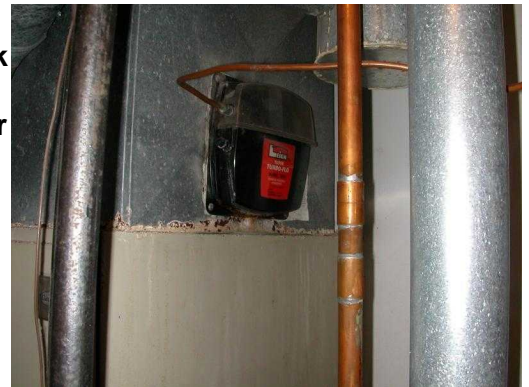
Humidifier: **The humidifier is turned off. It is a non-draining style and there is corrosion on the ductwork around it indicating prior leakage. It is probably not going to be an effective unit when used. Suggest a better humidifier be installed.**

3. Basement Heating System Humidifier: **The humidifier is turned off. It is a non-draining style and there is corrosion on the ductwork around it indicating prior leakage. It is probably not going to be an effective unit when used. Suggest a better humidifier be installed.**
