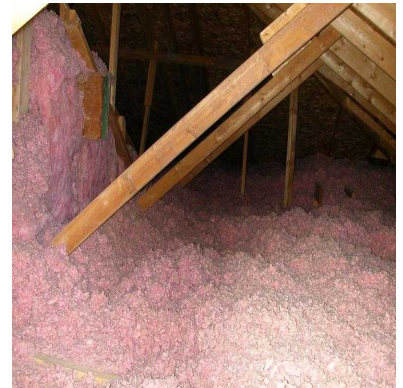
Main house Attic

- Roof Framing: **Rafters - 24" spacing**
- Sheathing: **Oriented Strand Board**
- Insulation Type: **Loose fill**
- Insulation Depth: **12" (approx. R-30). Insulation uneven - suggest more even distribution.**
- Vapor Barrier:
- Electrical: **110 VAC lighting circuit**

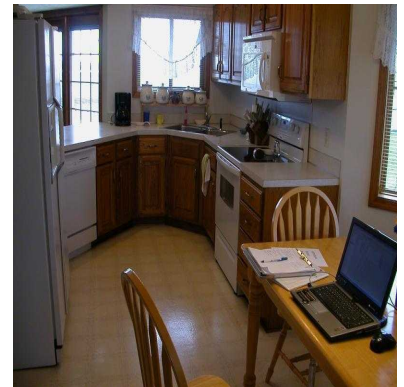
Present Kitchen _____

- Sink/Faucet **Double bowl with spray hose.**

- Dishwasher:
- Disposal:
- Range/Oven: **Electric range with electric oven.**
- Microwave:
- Exhaust Fan: **Present - recirculates**
- Cabinets/Countertops:
- Ceiling/Walls/Floor:
- Electrical: **110 VAC outlets and lighting circuits, 110 VAC GFCI**
- HVAC Source: **Forced air - registers**

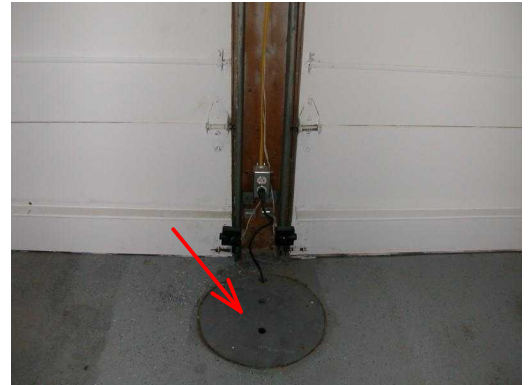
- Support Beams: **Steel I-Beam**
- Support Columns: **Steel posts.**
- Joists/Trusses: **2"x10".**
- Subfloor Decking: **Plywood**
- Stairs/Railings: **Wood stairs with wood handrails**
- Floor/Slab: **Concrete.**
- Sump Pit/Pump **Pit located at garage floor with a pump installed.**

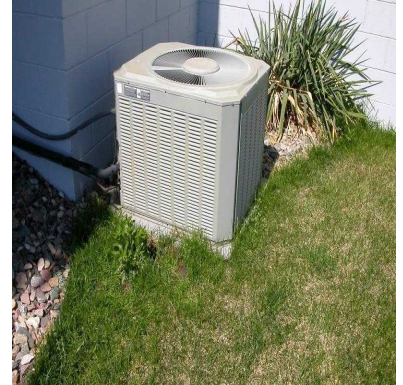
At Yard AC System _____

- General Condition **Appears functional - Temperature differential was within a 15 to 25 range.**
- Exterior Unit:
- Area Served: **Whole house** Approximate Age: **7 yrs.**
- Fuel Type: **220 - 240 Volt** Temperature Differential: **19 degrees**
- Type: **Central A/C** Capacity: **2.5 Ton**
- Electrical Disconnect:
- Exposed Ductwork:
- Blower Fan/Filters:
- Thermostats:

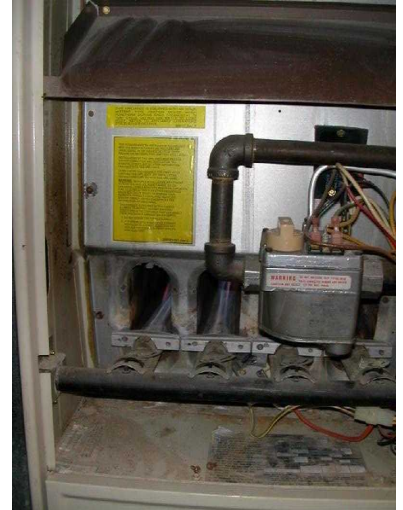
Basement Heating System

General Condition **Appears functional. A carbon monoxide test was performed on the air coming from the furnace and no abnormal levels were observed.**
